Manhole Inspection Summary

Manhole # S21MM1011MH

Insp Date: **11/9/06 9:46 AM**

Location Address: **4413 FALLS BRIDGE DR**

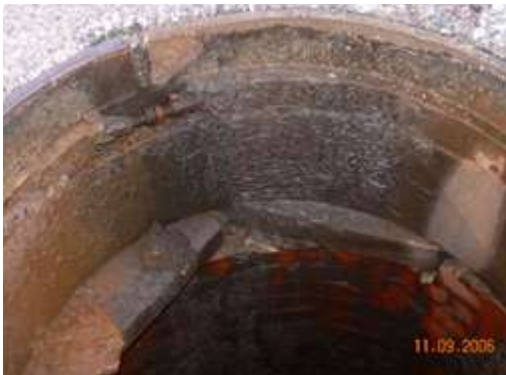
Defect

Frame Offset: **2** (in.) Condition: ☐ Sound ☐ Cracked ☒ **Leaks**

Condition: ☐ Sound ☐ Cracked ☐ Root Intrusion ☐ Loose Brick ☒ **Deteriorated**

Infiltration: ☐ None ☒ **Joint** ☐ Cracks ☒ **Mortar** ☐ Roots ☐ Wall

Frame leaks. Adjustment deterioration and infiltration.

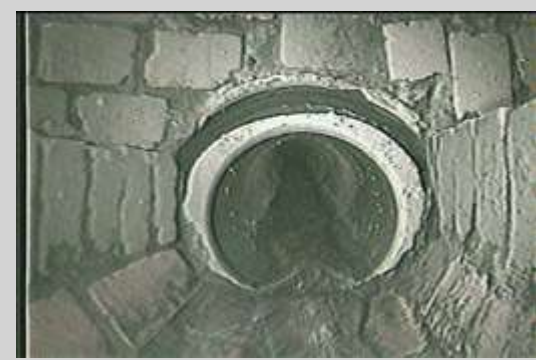
8 in. Circular Gravity Sewer Pipe Out @ 12 O'Clock

Rod and Bar (Angled)

Invert Depth: **10.78** (ft.) Flow Characteristics: **Slow**

Infiltration: **None** Pipe Seal Cond: **Unknown**

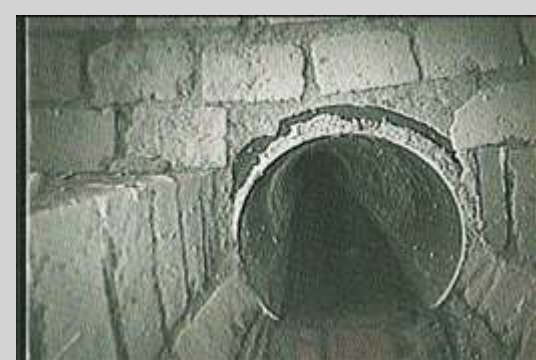
8 in. Circular Gravity Sewer Pipe In @ 5 O'Clock

Rod and Bar (Angled)

Invert Depth: **10.52** (ft.) Flow Characteristics: **Slow**

Infiltration: **None** Pipe Seal Cond: **Unknown**
